**US Army Corps
of Engineers**

Technical Report HL-94-1
May 1995

Demonstration Erosion Control Project Monitoring Program

Fiscal Year 1993 Report

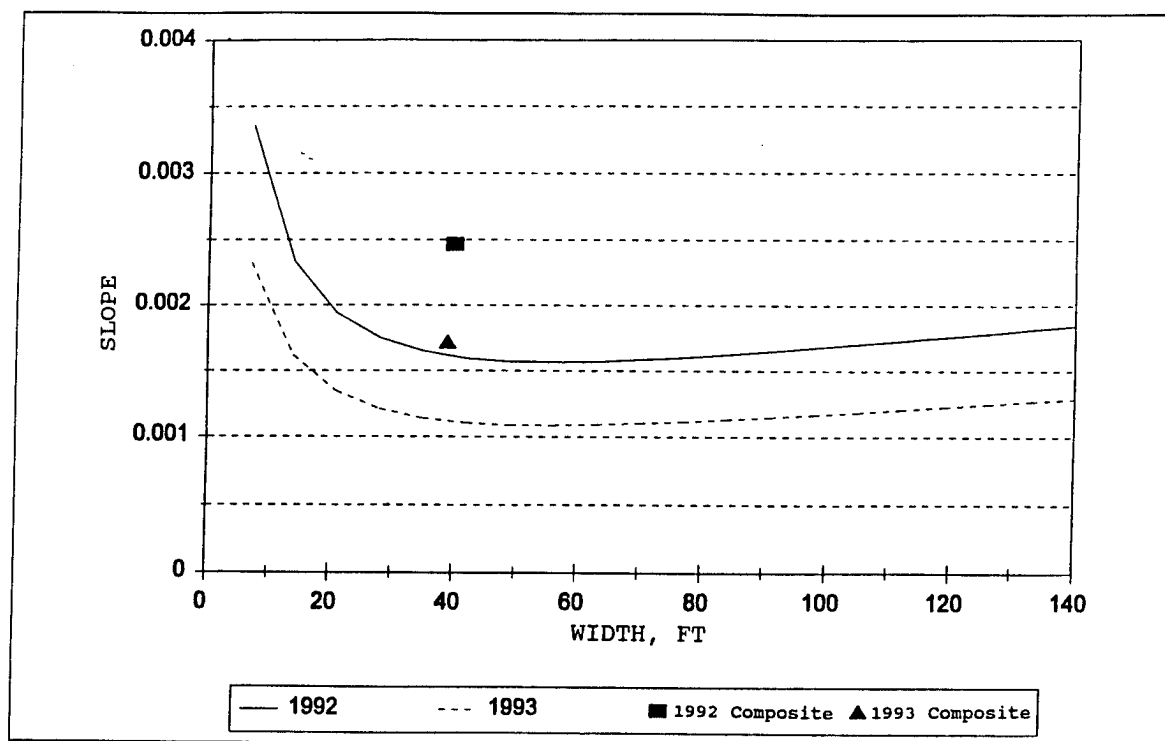
Figure 84. Comparison of 1992 and 1993 stable channel computations and composite cross-section data for segment 4, Middle Fork Worsham

Figures 81 through 84 are comparisons of the stable channel computations and the composite cross section data for segments 1 through 4 on Middle Fork Worsham Creek. Segment 1 and 2 data indicate that the slope of the stable channel has increased from 1992 to 1993, and that the composite section is degradational compared with the stable channel computation. More emphasis could be placed on the data if better roughness information was available. The segment 3 data are in agreement; however, the upstream portion of the segment will probably widen due to the channel evolution sequence phase of the channel. The segment 4 stable channel computation curve and the composite section have both decreased in slope, although the data indicate that the segment will continue to degrade. At 287 tons/day/foot of width, a reduction in sediment yield is desirable.

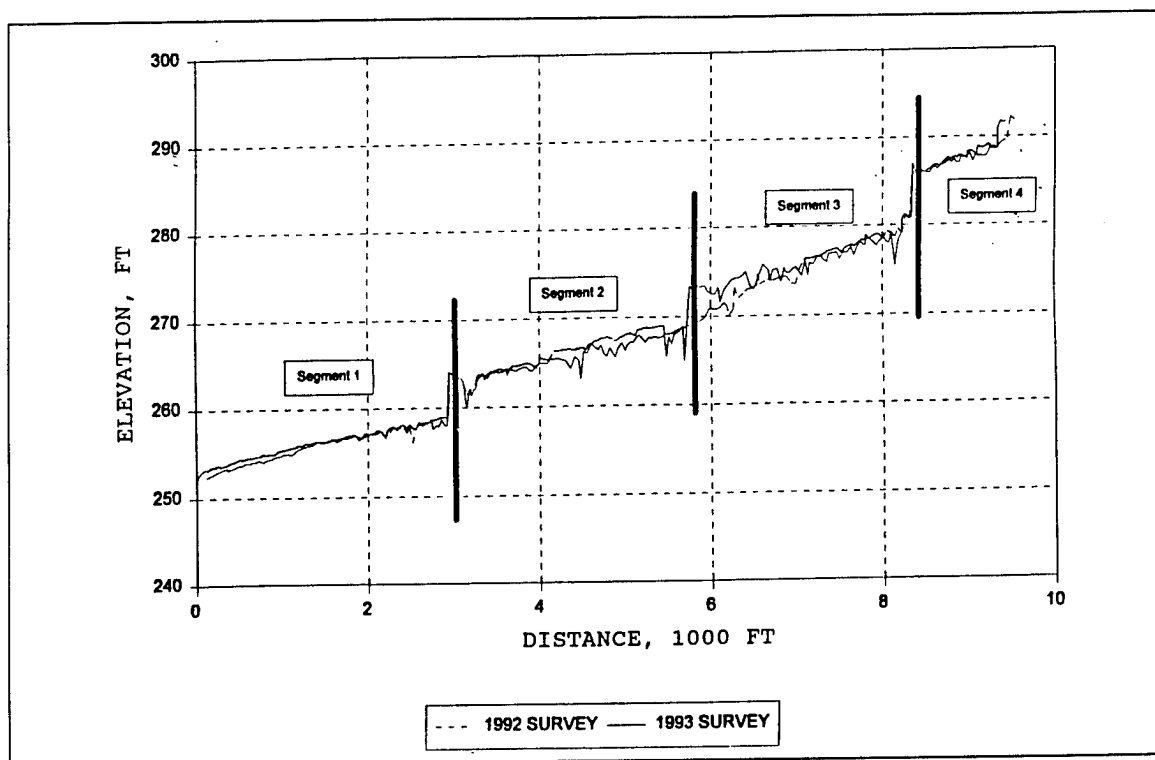
Figure 85. Comparison of 1992 and 1993 thalweg profiles for West Fork Worsham, Site 18

Figure 85 compares 1992 and 1993 thalweg profiles for West Fork Worsham Creek. Each of the four segments is separated by a lowdrop grade control structure. Relatively little change occurred in segments 1 and 4. Segment 3 aggraded in response to the downstream new grade control, while the upper portion of segment 2 degraded in response to the reduced sediment supply. Table 17 documents that the bed slopes decreased for each segment, and that the energy gradient decreased for segments 1, 2, and 3. The segment 4 energy gradient increased. This is confirmed in Figures 86 through 89, which compare stable channel computations and the composite cross section. For each of the first three segments the slope of the computed stable channel and the composite section decreased, although the position of the composite cross section implies that the channel will continue to degrade. Figure 89 indicates that the slopes are increasing and the creek is becoming more degradational.

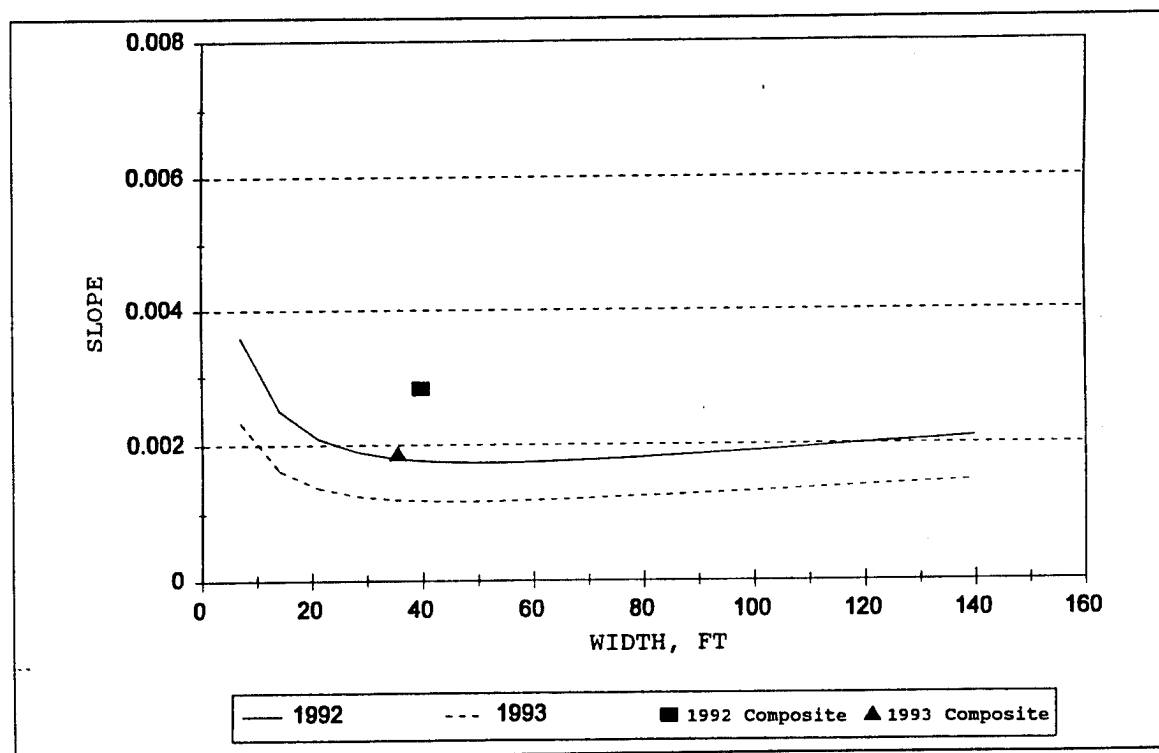
Figure 86. Comparison of 1992 and 1993 stable channel computations and composite cross-section data for West Fork Worsham Creek, segment 1

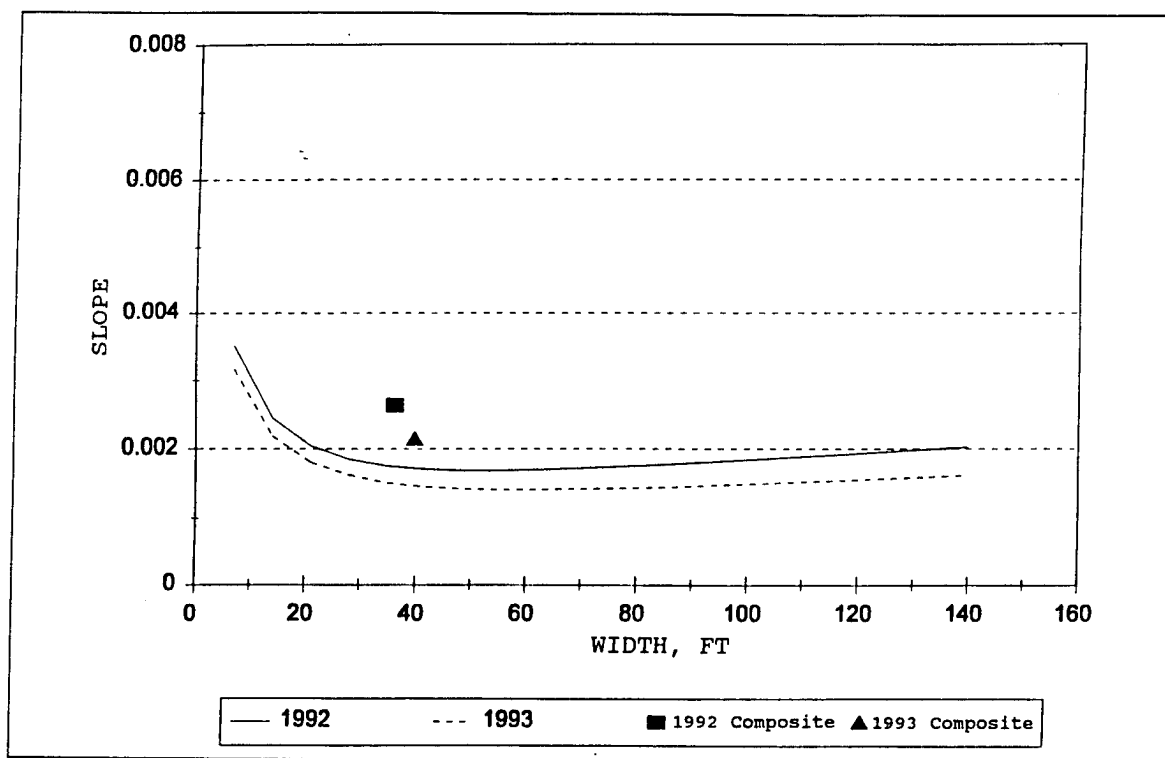
Figure 87. Comparison of 1992 and 1993 stable channel computations and composite cross-section data for West Fork Worsham Creek, segment 2

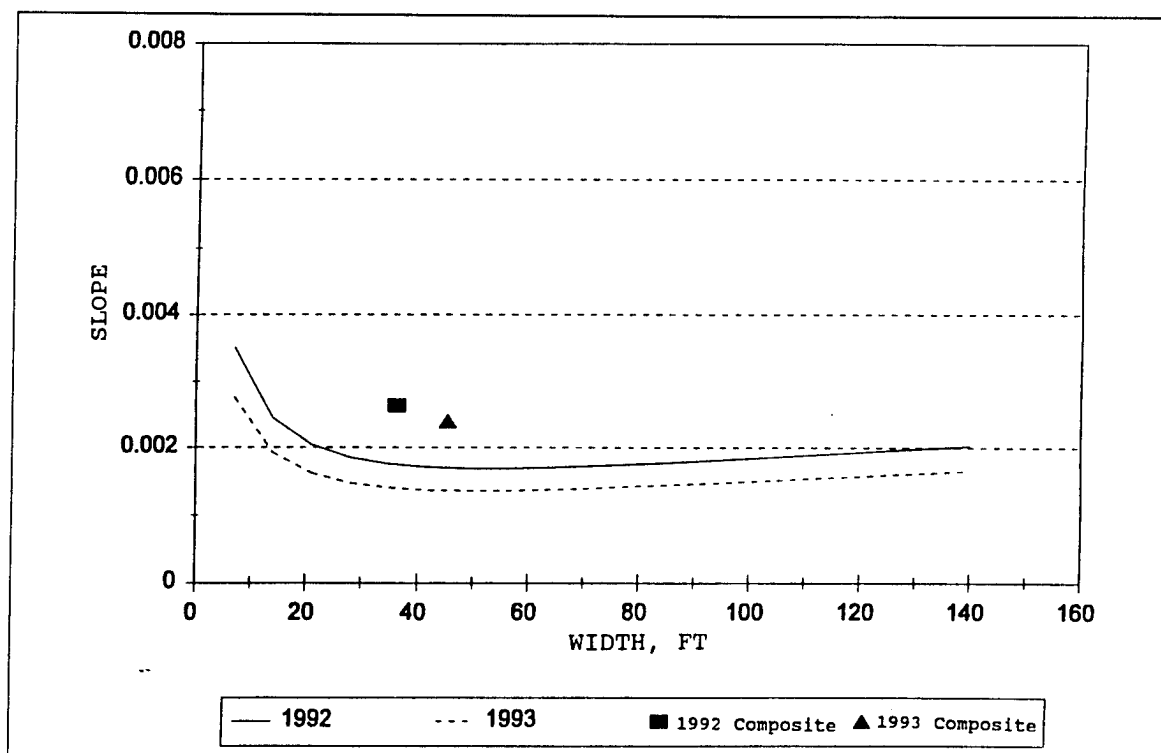
Figure 88. Comparison of 1992 and 1993 stable channel computations and composite cross-section data for West Fork Worsham Creek, segment 3

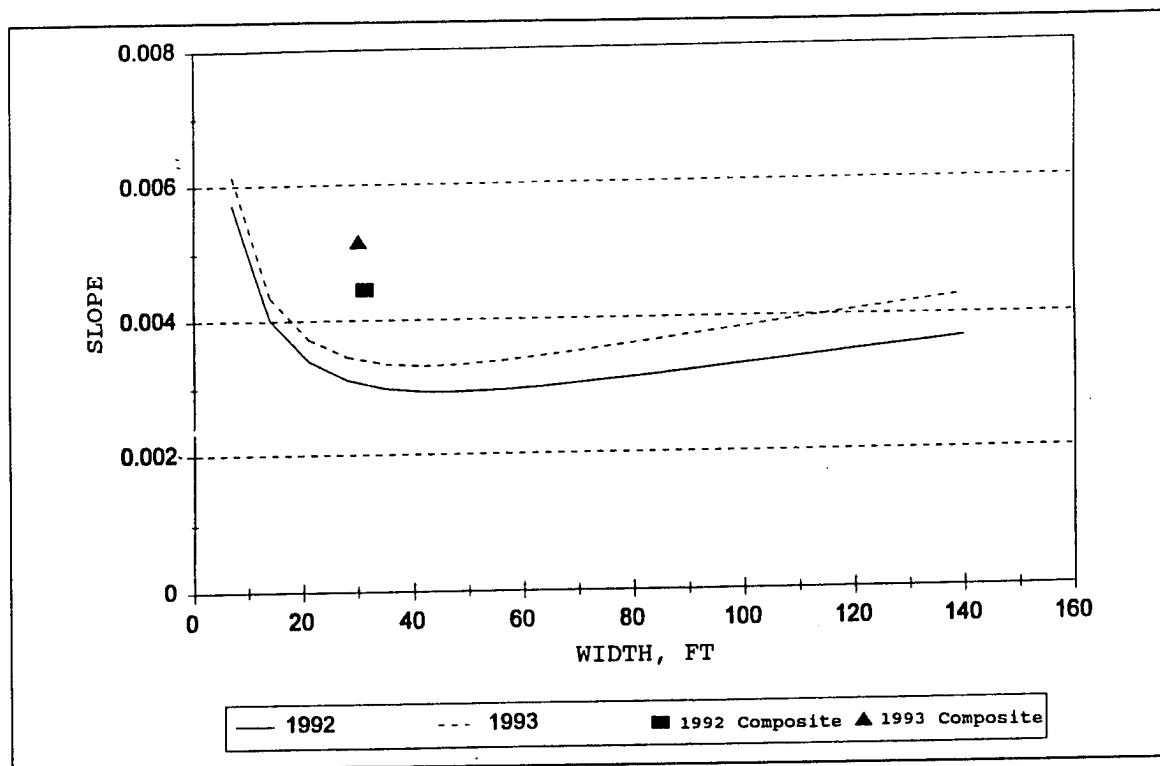
Figure 89. Comparison of 1992 and 1993 stable channel computations and composite cross-section data for West Fork Worsham Creek, segment 4

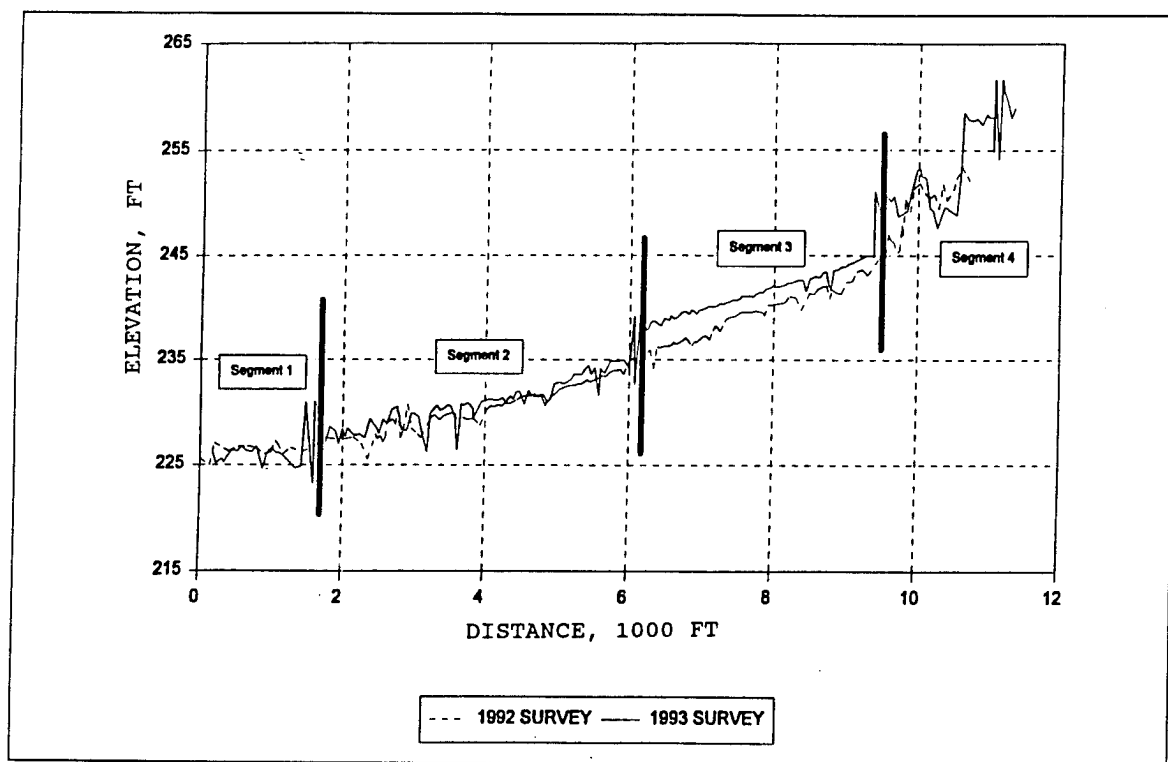
Figure 90. Comparison of 1992 and 1993 thalweg profiles for Perry Creek

Figure 90 compares thalwegs for Perry Creek. Segment 1 begins downstream of the first newly constructed drop structure, and segment 2 begins at the first new structure. Segment 3 begins at the second structure, and segment 4 begins at the third structure and encompasses the fourth structure, which was under construction at the time of the survey. Comparison of the surveys indicates aggradation in segments 2 and 3, and minor degradation in segment 1. The change in segment 4 is due to continuing construction.

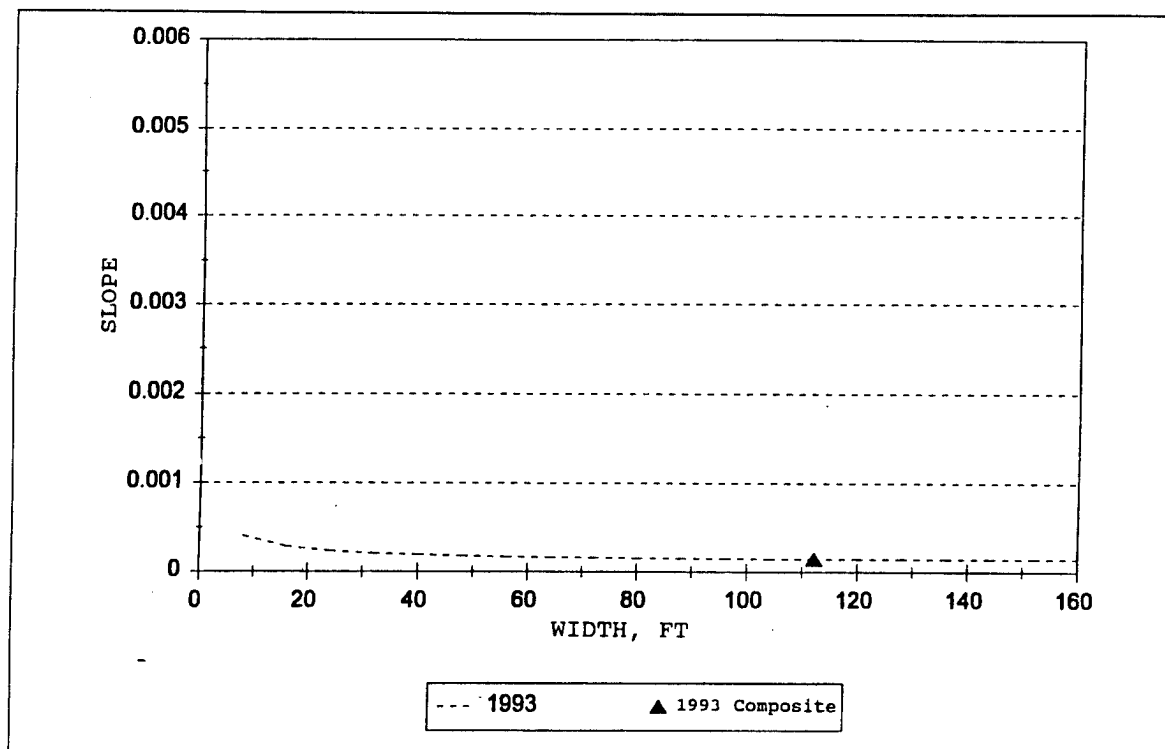
Figure 91. Comparison of 1993 stable channel computations and composite cross-section data for Perry Creek, segment 1

Table 18 summarizes the data and analyses for the site. Cross-section surveys were not available in 1992 due to survey error. Figures 91 through 94 compare composite cross-section data with stable channel computations. Sediment transport is very low for segments 1 and 2, and the energy gradient for segment 1 is less than regime. Channel response in segment 3 may be to

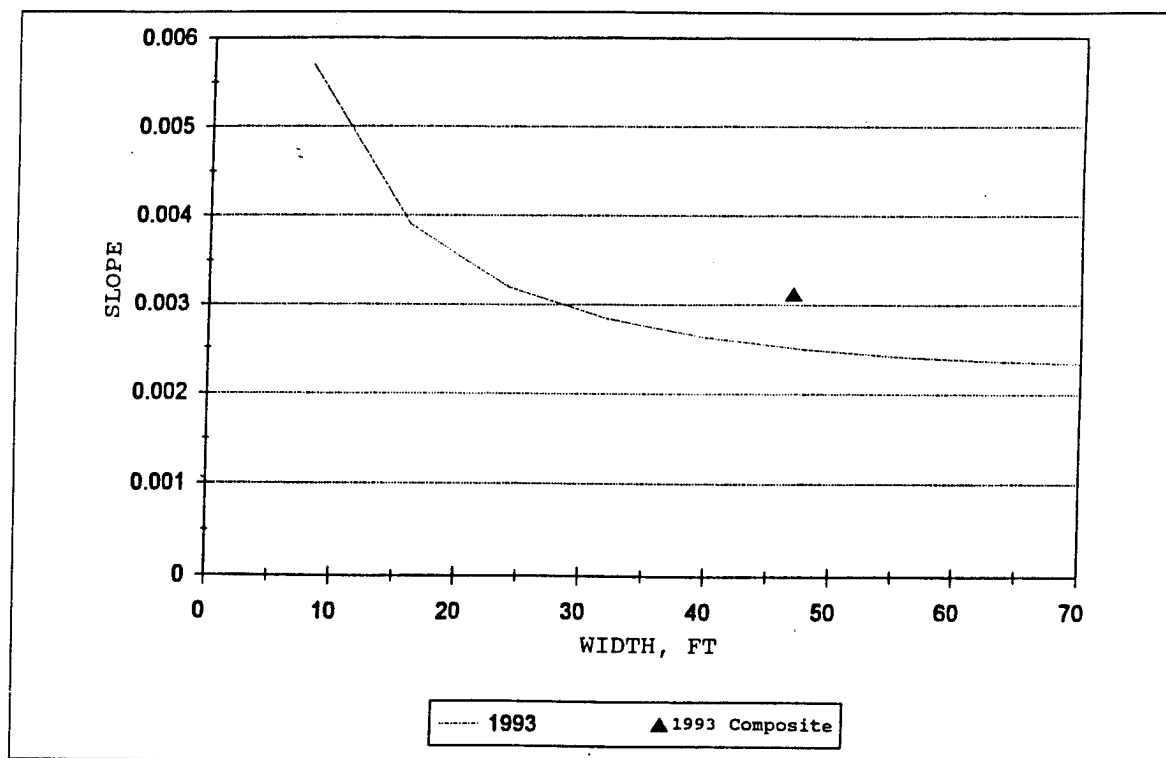
Figure 94. Comparison of 1993 stable channel computations and composite cross-section data for Perry Creek, segment 4

widen and result in a lower composite energy gradient. However, a portion of segment 4 bed material prior to construction was large (4- to 6-in.) iron-stone plates, which may be affecting the bed and energy gradient. Segment 4 transport is extremely high and is not realistic due to the ongoing construction. Four drop structures constructed in series with the improvements in structure and with the improvements in system configuration to affect hydraulic control should bring rapid and significant change to Perry Creek.

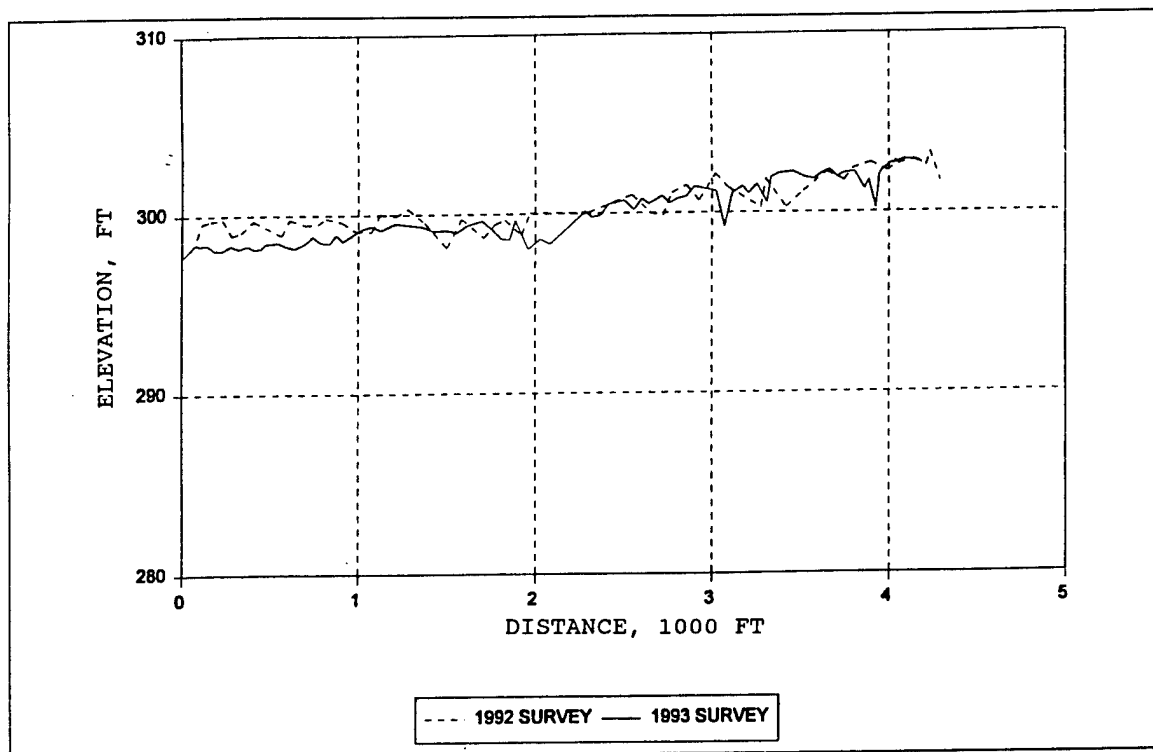
Figure 95. Comparison of 1992 and 1993 thalweg profiles for Otoucalofa Creek, Site 14

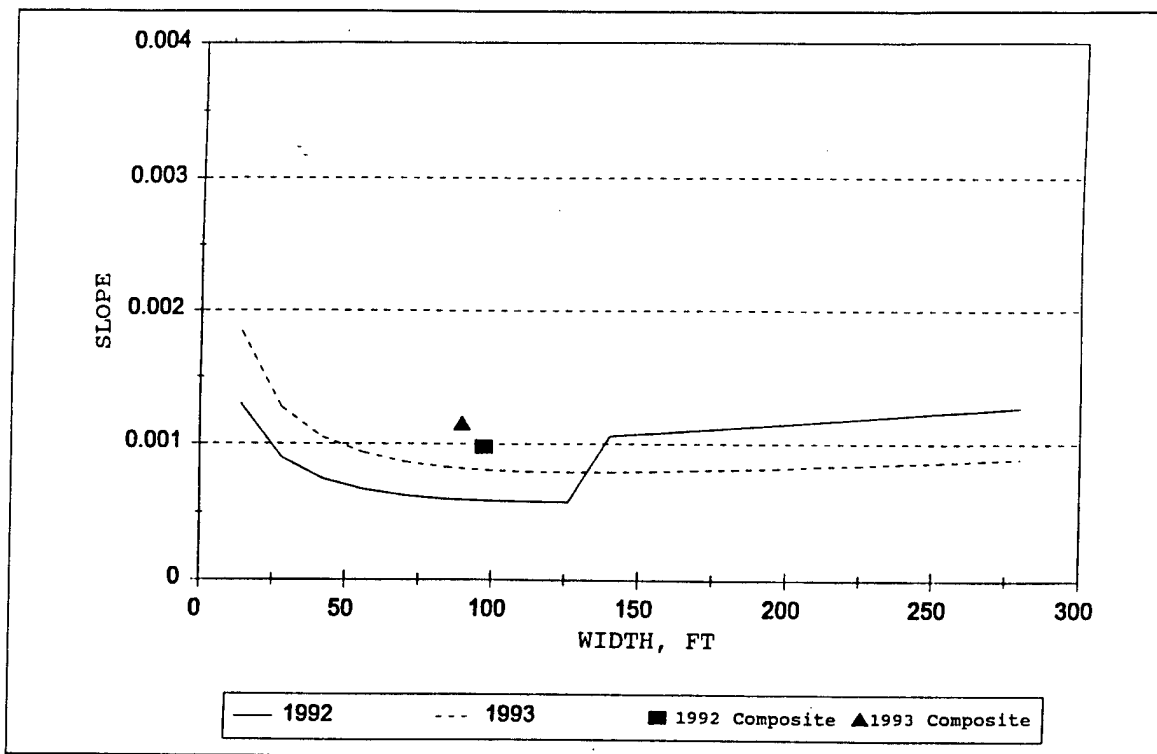
Figure 96. Comparison of 1992 and 1993 stable channel computations and the composite cross-section data for Otoucalofa Creek, Site 14

composite width is approaching the regime width. Sediment transport capacity has increased by 150 percent. Figure 96 compares the 1992 and 1993 stable channel computations and the composite section data, which indicate that the slope of the composite section has increased and that at the existing width the channel shifts from upper regime to lower regime. If sediment supply is to be reduced, the energy gradient must be reduced to establish stability. Consideration should be given to construction of a grade control structure or structures beginning downstream of the bridge to establish a lower energy gradient. Field evidence suggests that the channel will overbank at the existing condition and the grade control structures will decrease flood-control capacity.

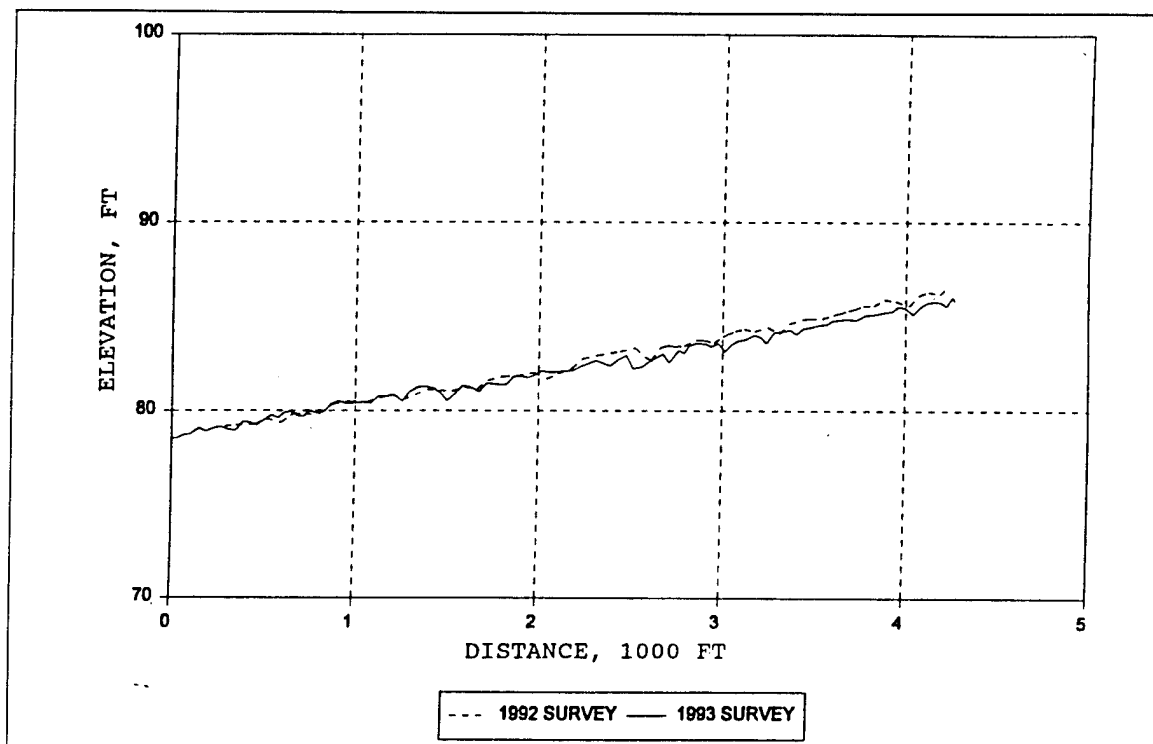
Figure 97. Comparison of 1992 and 1993 thalweg profiles for Sykes Creek, Site 17

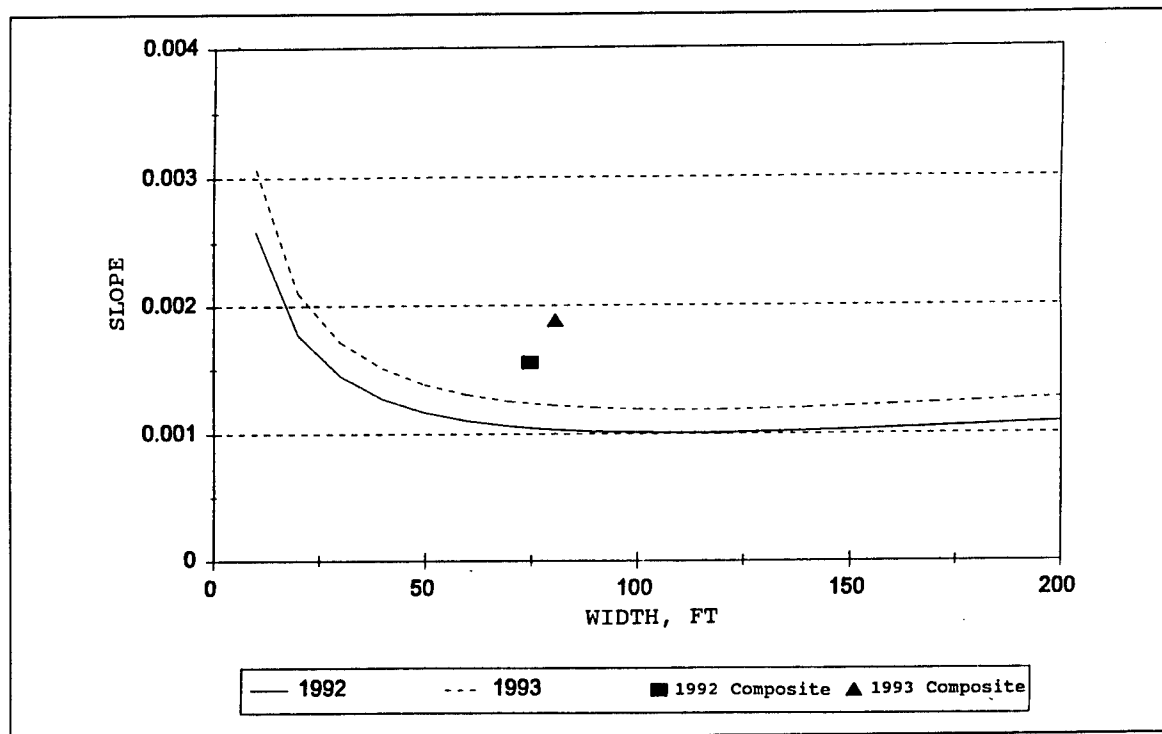
Figure 98. Comparison of 1992 and 1993 stable channel computations and the composite cross-section data for Sykes Creek, Site 17

indicate that although the bed has flattened, the composite energy gradient has increased, resulting in a 25 percent increase in sediment transport capacity. Figure 98 compares the stable channel computations and the composite cross-section data, which indicate that the site will continue to be degradational.

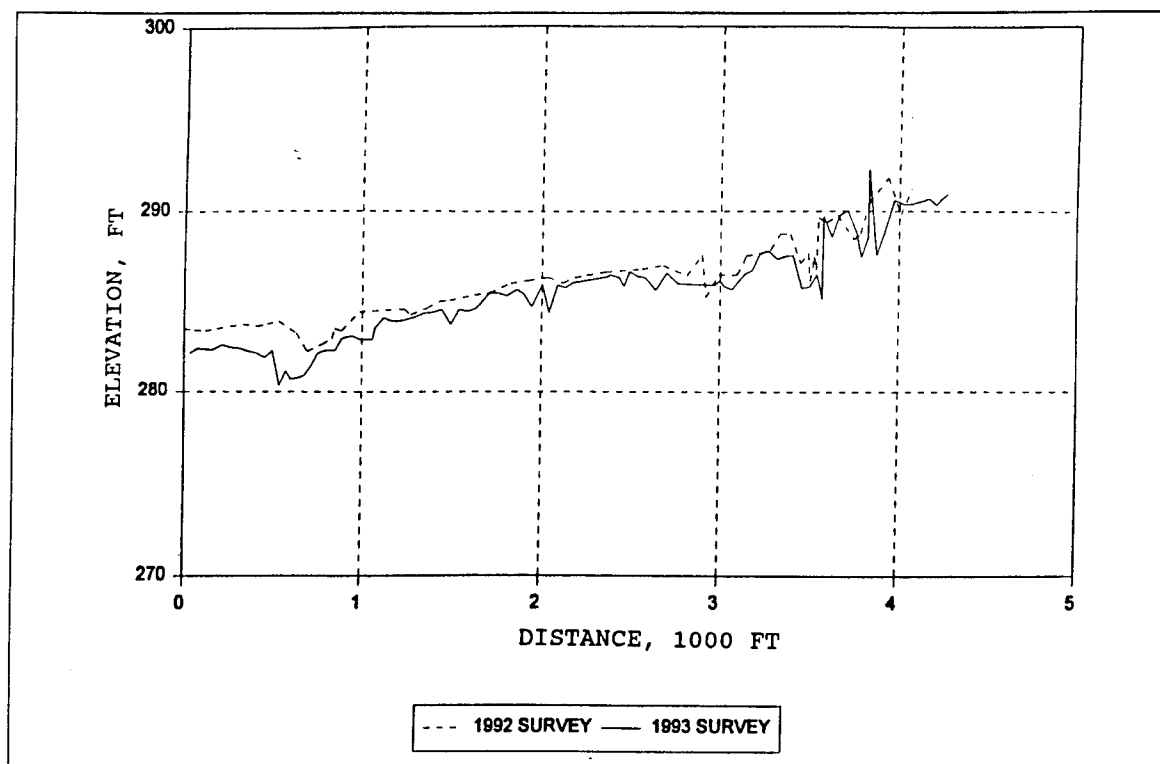
Figure 99. Comparison of 1992 and 1993 thalweg profiles for Fannegusha Creek, Site 2

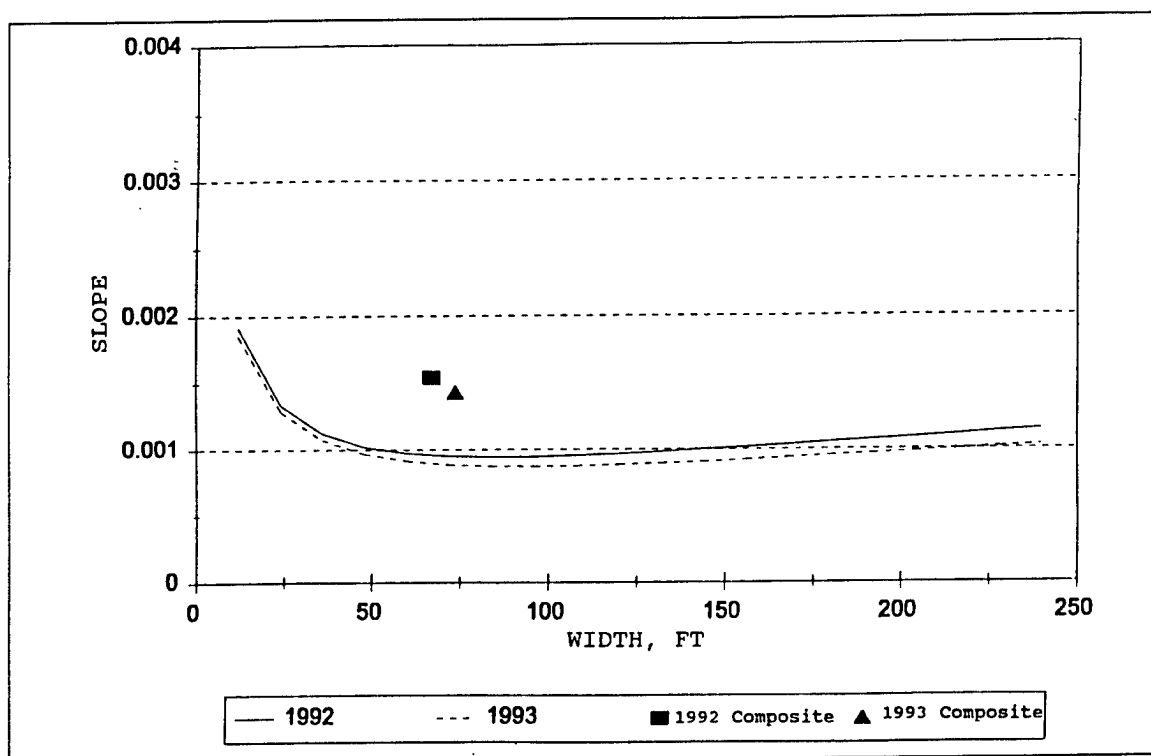
Figure 100. Comparison of 1992 and 1993 stable channel computations and the composite cross-section data for Fannegusha Creek, Site 2

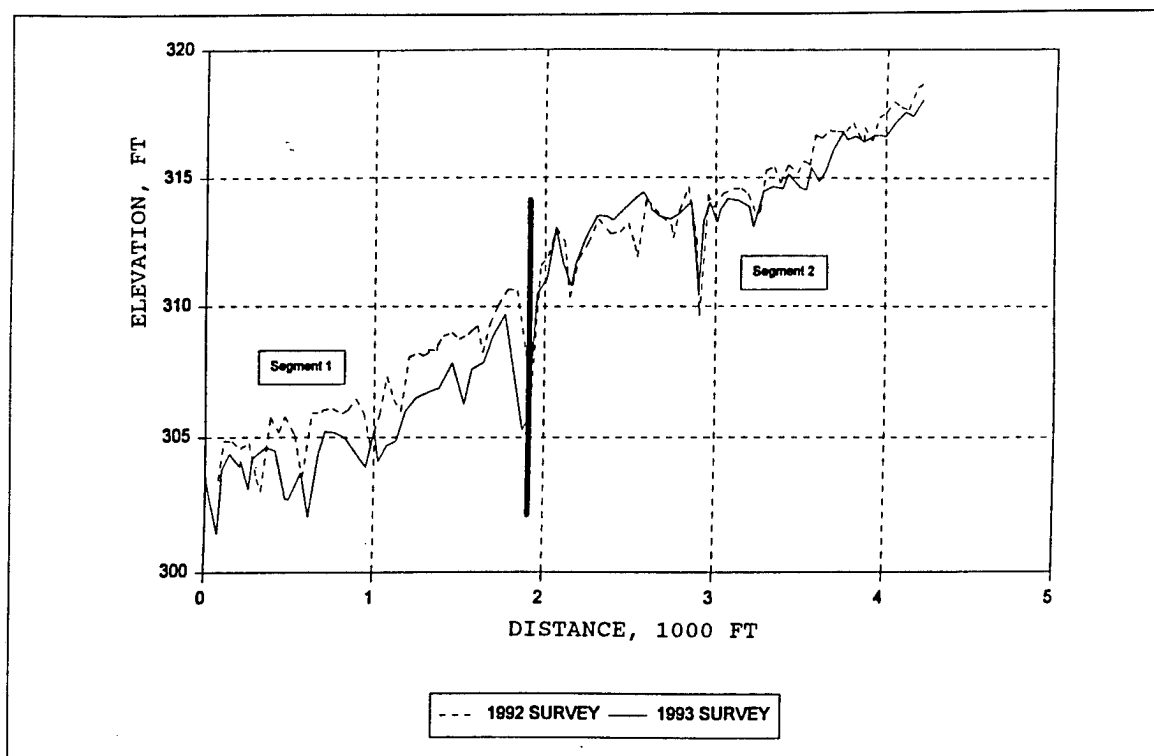
Figure 101. Comparison of 1992 and 1993 thalweg profiles for Lick Creek, Site 8

Figure 101 compares the 1992 and 1993 thalweg profiles, which show continuing degradation. The bed slopes range from 0.0025 to 0.003. However, the composite cross-section energy gradient indicates that the gradient is decreasing and that sediment transport is decreasing (Table 22). This is also supported by Figures 102 and 103, which indicate lower stable channel slopes for the upstream segment 2. Unfortunately, segment 1 remains degradational, and the degradation can be expected to move upstream. These data suggest that the temporary riprap fill may be resisting the channel incision. Construction of the planned high-drop and review of gully formation in the upstream flooded reach are recommended.

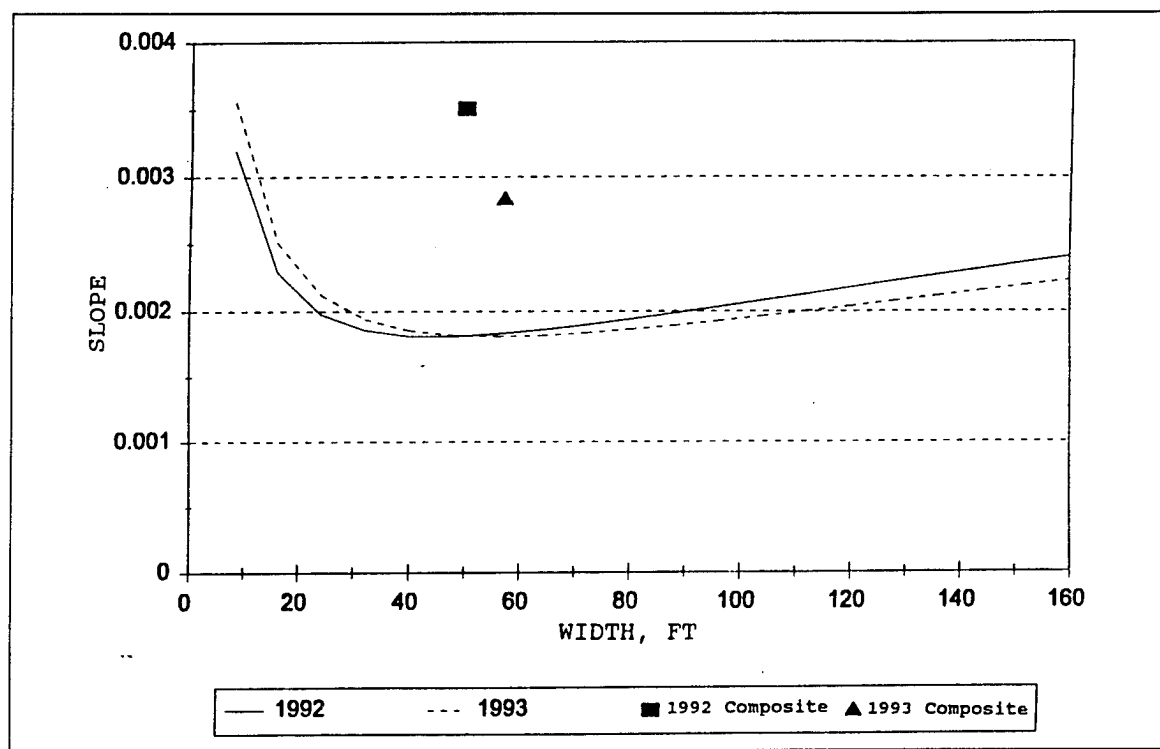
Figure 102. Comparison of 1992 and 1993 stable channel computations and the composite cross-section data for Lick Creek, segment 1

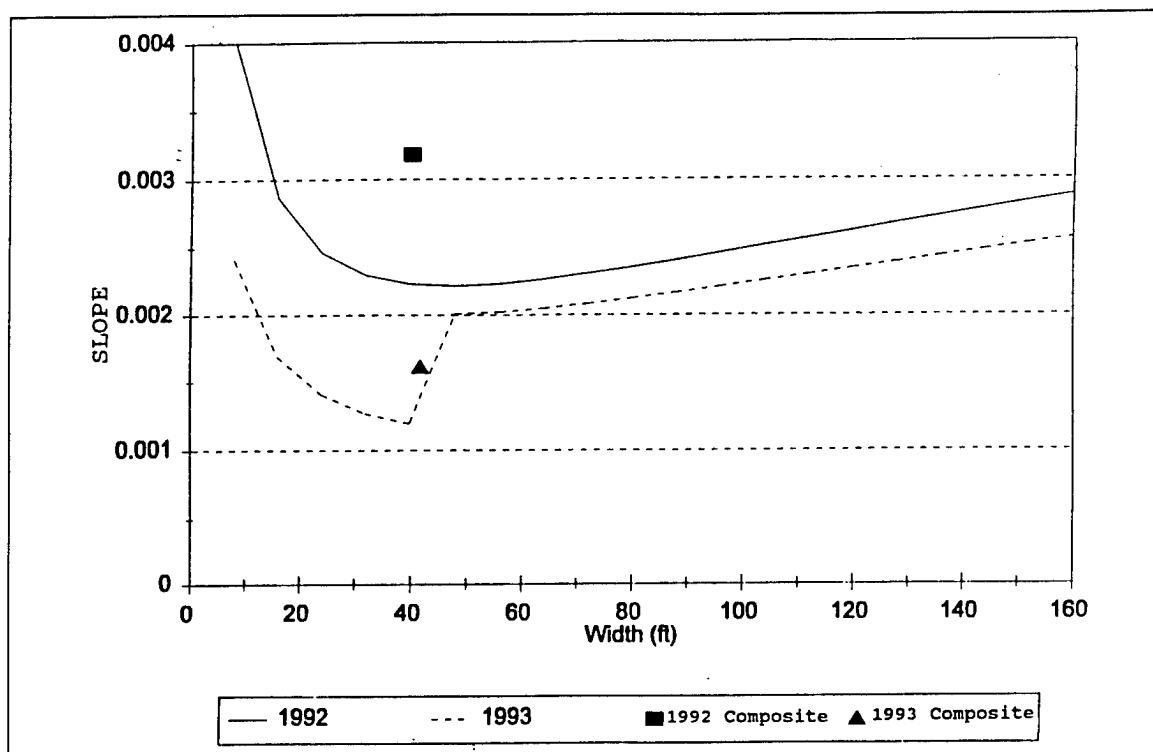
Figure 103. Comparison of 1992 and 1993 stable channel computations and the composite cross-section data for Lick Creek, Segment 2

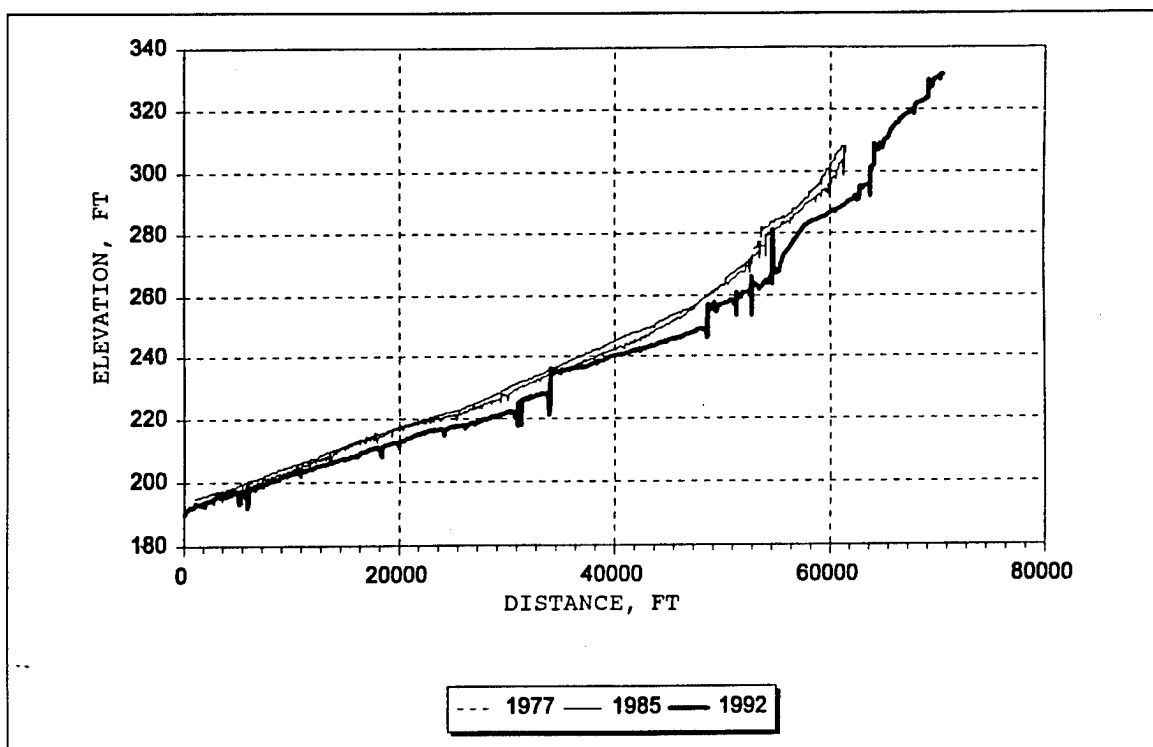
Figure 104. Comparison of 1977, 1985, and 1992 thalweg profile comparisons for Hotophia Creek

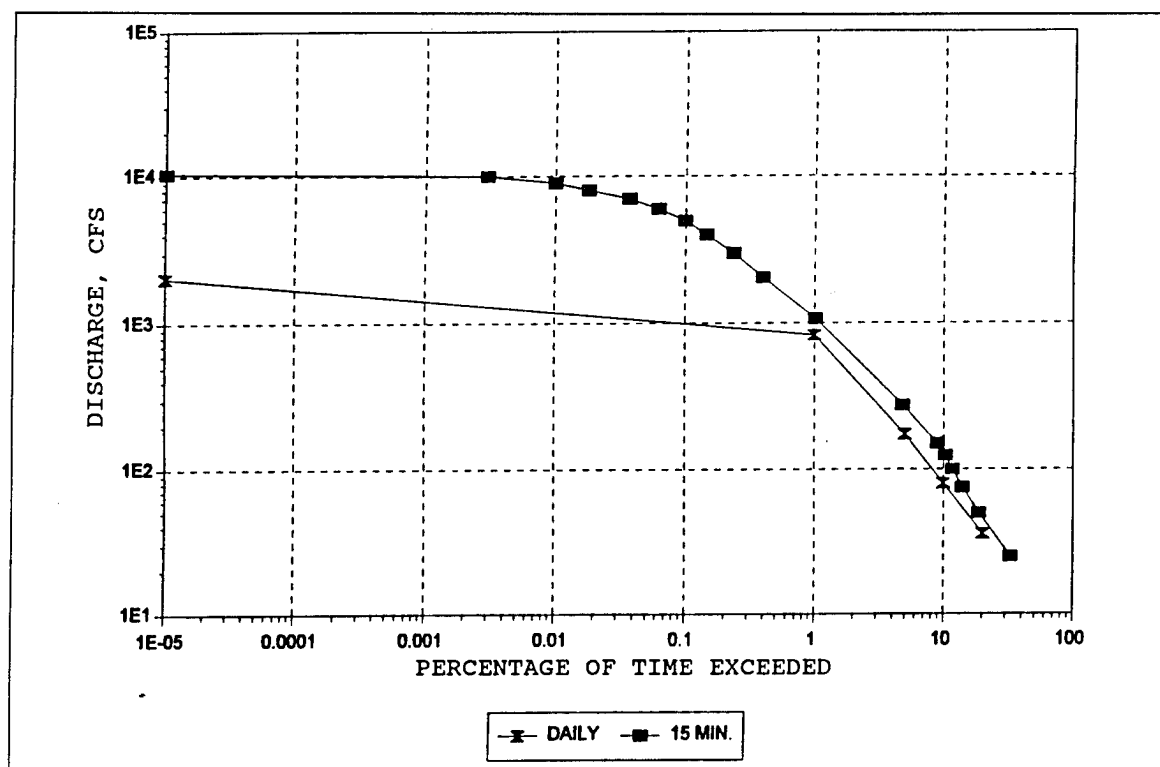
Figure 105. Comparison of flow-duration curves developed from mean daily discharge and 15-minute discharge sampling interval

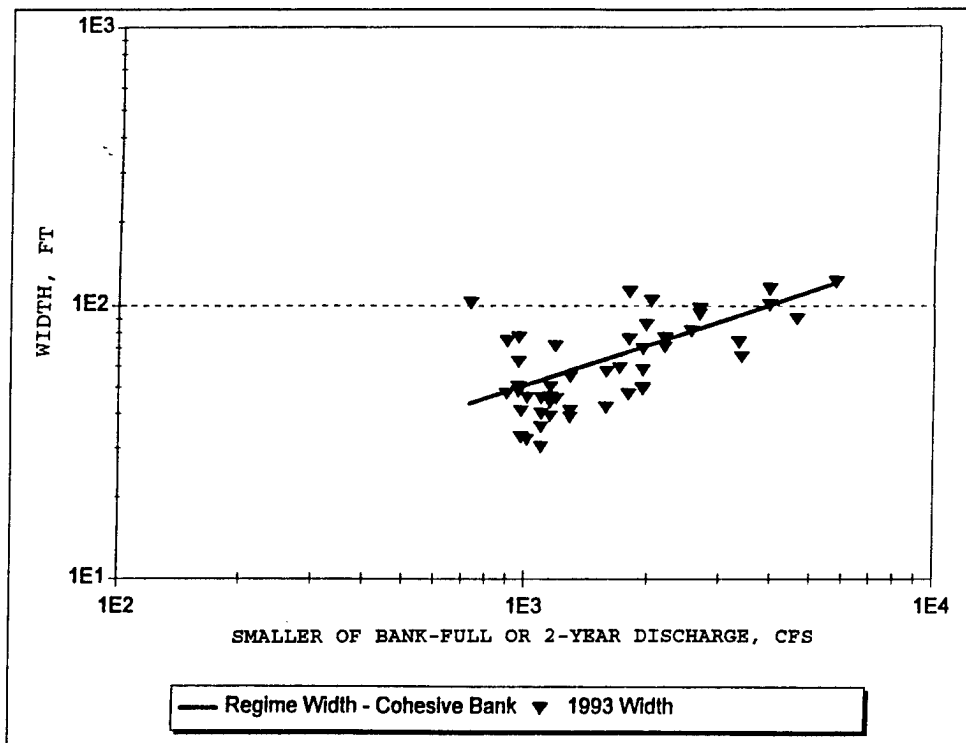
Figure 106. Comparison of regime width and composite width for Hotophia Creek

Comparisons of the 1992 and 1993 composite section average width, depth, and slope with the regime average predictions indicate that the regime procedure yields reasonable values for width and depth. The composite averages for 1992 and 1993 width are 91 percent and 89 percent of the regime prediction, respectively. Similarly, the composite depth averages for 1992 and 1993 are 81 percent and 82 percent of the regime prediction, respectively. Composite slope values are 467 percent and 391 percent of the regime predictions for 1992 and 1993, respectively. The relationship for width is depicted in Figure 106, and the relationship for depth is depicted in Figure 107. The regime depth prediction appears to be a practical upper envelope value, while the width prediction line has a more even distribution. Figure 108 depicts the 1993 composite slope values, the regime slope prediction, and a line representing the Vicksburg District slope-area relationship. Clearly, the slope-area relationship is a better predictor than the regime method for slope using this data set. The slope-area curve was developed for the basin in which the 1993 slope values were computed. The 1993 composite values represent a diversity of stable and unstable channels, and no conclusions should be drawn concerning the stability of the streams based on Figures 106, 107, or 108. With only discharge and drainage area a reasonable

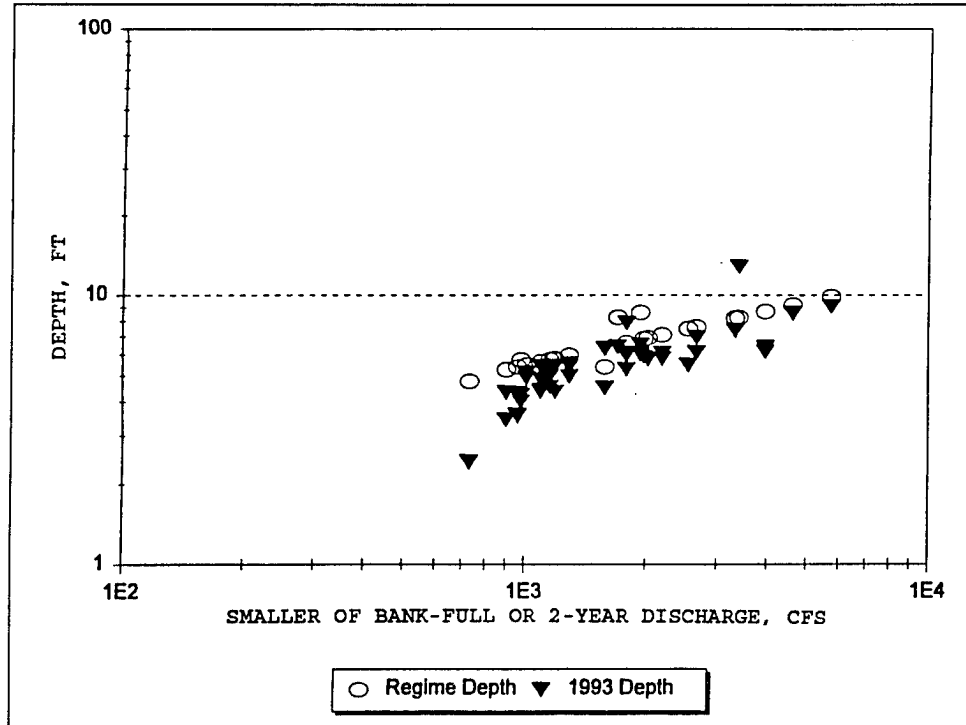
Figure 107. Comparison of regime depth and 1993 composite depth for Hotophia Creek

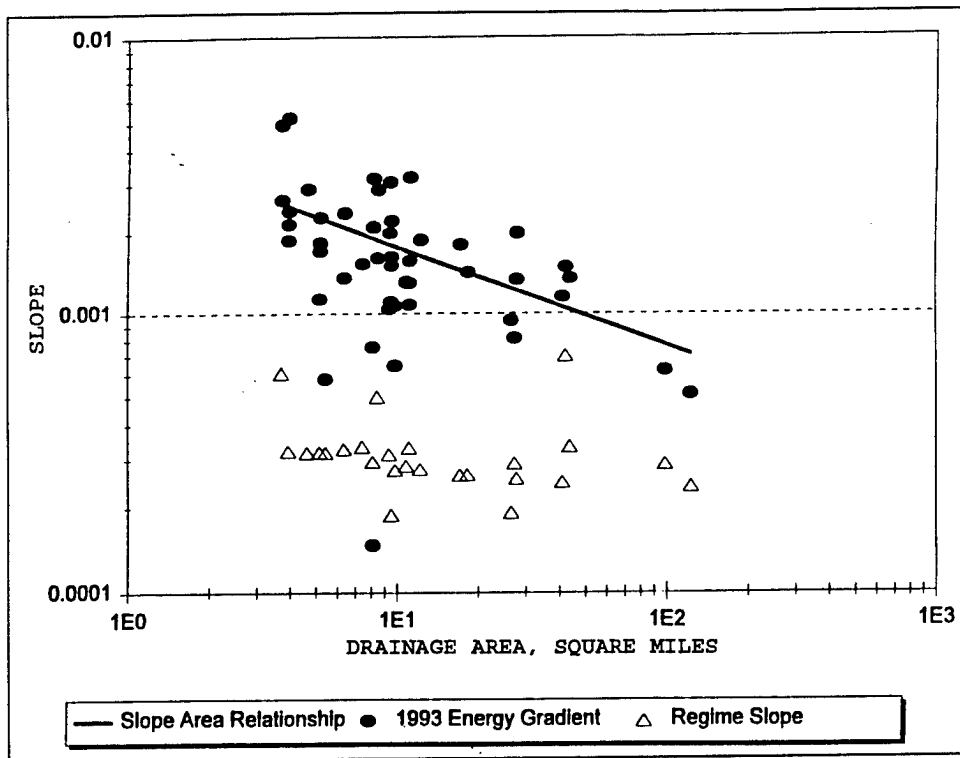
Figure 108. Comparison of slope for Hotophia Creek
